6th Asia Pacific Workshop on Structural Health Monitoring, 6th APWSHM

## Combination Non-Destructive Test (NDT) Method for Early Damage Detection and Condition Assessment of Boiler Tubes

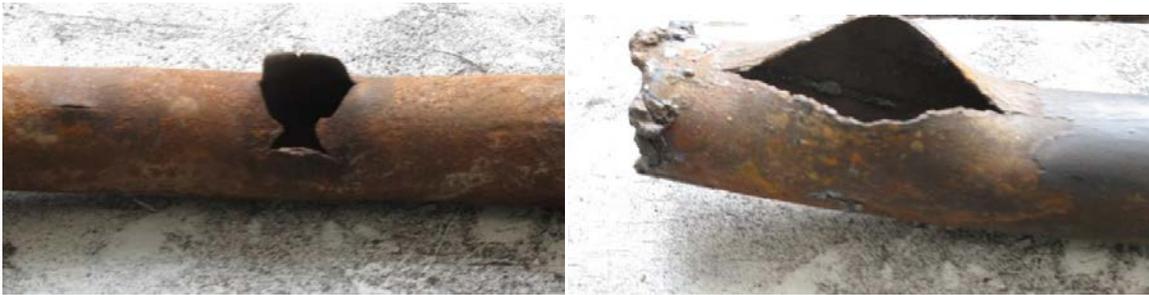
Figure 1: Most common damage mechanisms observed in boiler water-wall with carbon steel material (Steel20). Surface corrosion and erosion causing wall thinning (*left*), thick-lip burst caused by long-term overheating and creep damage – note multiple longitudinal cracks in the vicinity of a burst (*right*).

These initial investigations that included plant visits and literature search had concluded that in order for this research to be useful to plant operators, it has to concentrate on carbon steel as a material of choice for water-wall section of the boiler. The most common reasons for tube failures in Steel20 were: (i) external and internal corrosion and erosion - it is common for combustion products to erode portions of the tube surface or for chemical reactions of molten sulfates, carbonates and oxides with the iron in tube material to locally reduce the tube wall thickness (ii) long-term overheating damage where the material strength gradually decreases with time (iii) short-term overheating, usually occurring during start-up or due to some unexpected occurrences, such as tube blockage, when tube temperature rises suddenly with consequent loss of tensile strength, so that hoop stress from internal pressure causes a violent rupture. It needs to mention at this point that both above types of failure are easy to recognize by a simple observation: while a long-term overheating causes a “thick-lip rupture” with many bulges and cracks visible around, a short-term overheating is connected with “thin-lip rupture” having sharp edges and usually no evidence of other damage around the burst [5]. Samples of actual tube failures are shown in Figure 1.

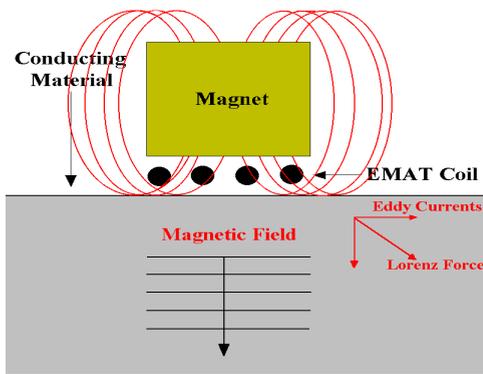
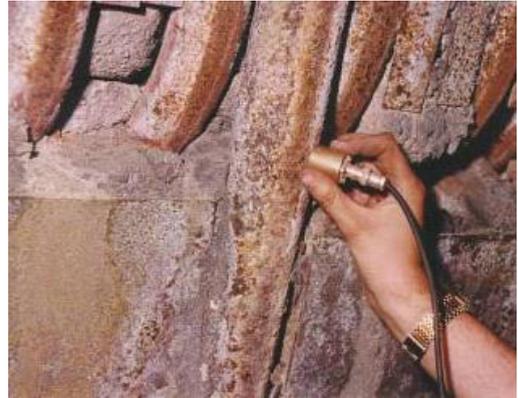
Figure 2: Principle of EMAT (left) and the manual EMAT thickness measurement performed on boiler tubes (right)

EMAT principle is well known and it relies on generating ultrasound wave directly in the metal without a need for a couplant. The EMAT transducer has a strong permanent magnet, usually Neodymium-type and a spiral coil supplied with a current of high frequency (1-2MHz). The current in the coil induces eddy currents on the surface of tested tube and the magnet "pushes" those currents into the tube in the form of elastic wave with ultrasonic velocity, characteristic for a given metal. There are two ways that EMATs can generate elastic energy directly in the boiler water-wall. The first is via the "Lorentz force" mechanism where interaction between an applied magnetic field and induced eddy currents produces an elastic wave. The second is through magnetostriction (MS), where an alternating magnetic field generates an alternating elastic force. While the Lorentz force mechanism has been proven to work well on boiler tubes, but it requires much higher magnetization and systems are heavier and more costly than their magnetostrictive counterparts. The steel surface have low magnetostrictive properties and for that reason, clean tubes cannot generate sufficient EMAT signal for useful inspection. However, when the metal is exposed to conditions commonly encountered in the fire box of coal-fired boilers (temperatures over 400-450C), a tightly bonded scale having a large MS coefficient is formed [2]. EMAT transducers can work with general-purpose ultrasonic instruments with certain modifications, most important being the adequate initial pulse, at least 400V. Figure 2 shows the EMAT principle and how the manual inspection is done on boiler tubes.

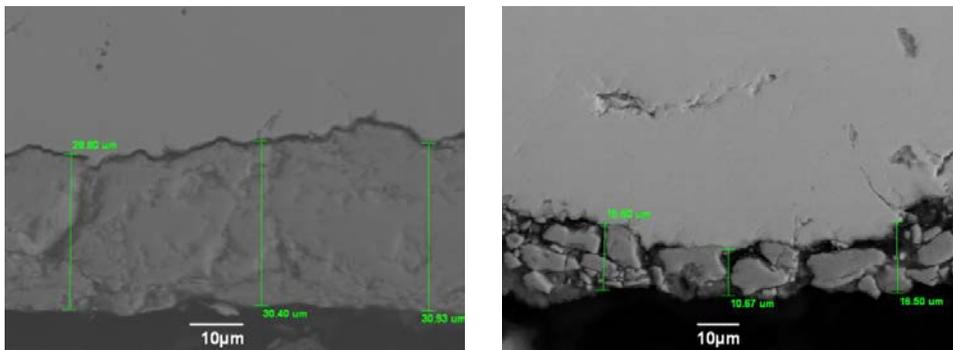
Sample No.	O (%)	Na	Al	Si	Cl	Fe
1 (left)	18.62	4.41	1.54	3.79	0.48	71.16
2 (right)	16.11	4.81	1.88	5.08	0.43	70.27

Fig. 3. Microphotographs of two samples with external oxide scale of various thickness with their corresponding chemical analysis. A solid EMAT signal was obtained for the sample on the left while the sample on the right has produces only a sparse signal. This was most probably due to lack of adherence between the scale and parent metal.

adequate magnetostrictive properties to generate EMAT signal. It is not critical where the scale is located (ID vs. OD) as good indications were obtained with scale on either surface while testing from the outside. More important than location is the chemical composition of the scale, determining its magnetostrictive properties and its adherence to the parent metal [7]. The scale thickness was found not to be that important as authors were able to obtain good EMAT indications through scale ranging from less than few microns to 7mm thick [8]. To determine the chemical composition of the scale and to compare it to boilers in other regions of the world, the spectrometry was performed with further investigation by SEM. Figure 3 shows two microphotographs of external scale with various thicknesses, various degree of adherence to parent tube metal with their corresponding chemical composition.

Neither chemical composition nor ferrous oxides contents differed from typical values obtained in other regions of the world. Occasional lack of coupling was most probably caused by non-adherence or loose adherence of the scale to tube material.

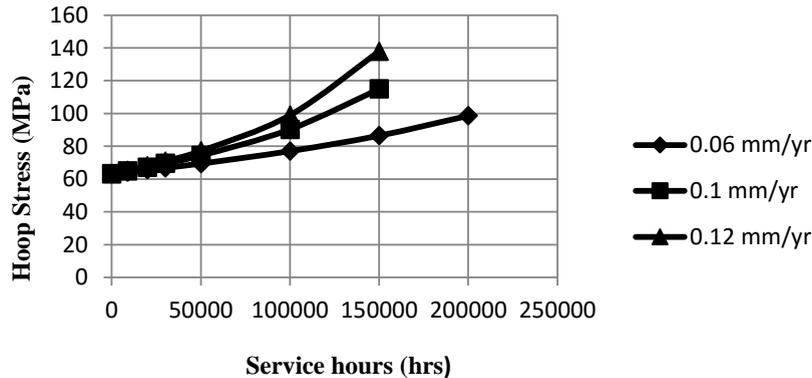
Fig. 4. Hoop stress growth in boiler tubes as a function of thinning rate

An exemplary graph of hoop stress for various rates of thinning are shown in Fig. 4 below:

- 4) On the same scale, superimpose the graph for hoop stress as a function of time for a thinning rate as determined by periodic EMAT inspection (as in Fig. 4). The estimated remaining tube life can be then determined on the intersection of both curves as shown in Fig. 6 right (for 0.06 mm/yr thinning rate):

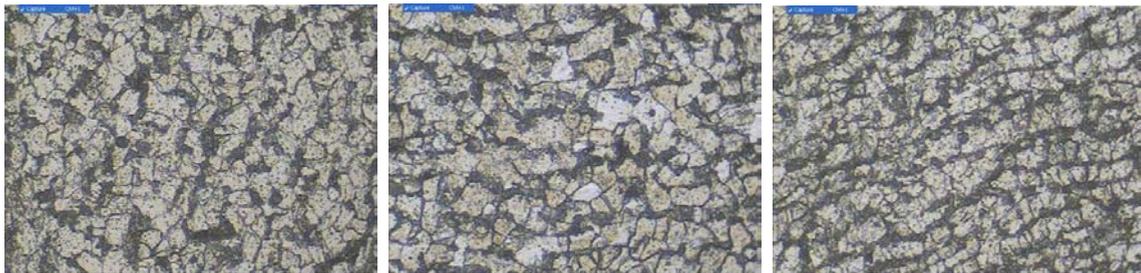
Fig. 5. Metallographical structures for Steel 20. Sample without presence of internal oxide (*left*), with oxide scale 75 micron thick (*center*) and with 140 micron thick (*right*). Ferritic-pearlitic structure observed in all samples with occasional inclusions in ferrite grains. Sample in the *center* differs by enlarged and elongated grains, indicating the initiation of structural degradation. Sample on the *right* has grains elongated with insoluble carbides “bundled” and precipitated on grain boundaries. This is indicative for creep.

During this research, an attempt was made to develop a correlation between the thickness of internal scale and the “degree of creep damage” for Steel20 samples. While similar correlation has been investigated for Cr-Mo steel, it was never evaluated before for low carbon steel. The initial work was done on three samples taken from boiler: one without any internal scale and two samples with scale of 75 and 140 microns measured by optical microscope. Metallurgical cross sections were prepared at or close to mid-wall location and metallurgical structures were observed by optical microscope. Figure 5 shows the comparison between samples with and without internal oxide at 400X magnification together with appropriate discussions and explanations.

The discussion in this paper was intended to demonstrate the value of non-destructive testing in evaluating boiler condition and in providing an important input to Remaining Life Assessment (RLA). The question arises how to treat a combined effect of both overheating and wall thinning, which will determine the way NDT results are utilized. To-date, both results are treated separately, and consequently separate reject criteria exist for overheating and separate for wall thinning. Overheating has been historically evaluated by destructive methods and degradation is then determined by loss of tensile strength, change in hardness and finally by observing metallographic structure under optical microscope. Certain criteria were developed for measurable properties (strength, hardness) but evaluation of structural degradation is still somewhat subjective. Special classification methods exist, such as Toft & Mardsen method [10] that classifies the condition by six (6) stages of spheroidization of carbides: from Stage A – structure not affected by creep to Stage F – structure pre-failure, demonstrating microcracks and cavities with no trace of original pearlitic areas. This method was designed for Cr-Mo steels and there is no prior history of its successful use in carbon steel. Using this method to structures shown in Figure 5 above, the *center* structure is classified as between Stage A and B and the *right* structure is between Stage B and C.

- 1) Determine the mean temperature from thickness of internal oxide scale. As an example, the metal structure as shown in Fig. 5 (right) with 140 mils oxide scale was selected. By applying formula (3), the mean temperature was estimated as 470C.
- 2) Calculate LMP according to formula (4) above by inserting previously determined mean temperature for several different values of time-to-failure hours. In an example shown here, the LMP was calculated for 470C temperature and time-to-failure: 10,000; 50,000; 100,000 and 150,000 hrs. The calculated values of LMP were: 32.1; 33; 33.45 and 33.69 respectively.
- 3) For each calculated LMP, read the corresponding value of hoop stress-to-failure from graphs available for carbon steel [16], and create the curve: hoop stress (y) vs. time-to-failure (x). In our example, the graph [13] was reduced to the following formula for a simplicity:

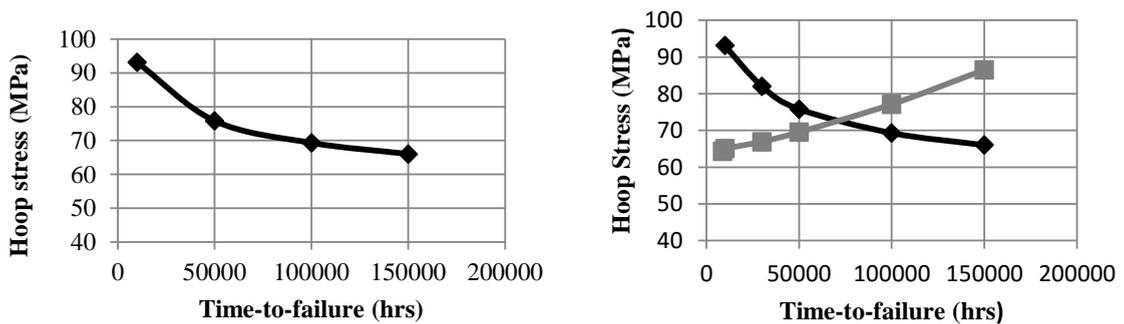
Fig. 6. Hoop stress as a function of time-to-failure for exemplary case of tube overheated to 470C (left) and the same curve with superimposed graph of hoop stress as a function of wall thickness at steady thinning rate of 0.06mm/yr (right). The tube remaining life is read on intersection of both curves, in example above, approx. 70,000 hrs.

and values for LMP were used as shown in Item 2 above. This allowed for creating a graph of a hoop stress as a function of time-to-failure. Further, stress units (psi) were re-calculated to metric system (MPa). The resultant graph is shown in Fig. 6 (left).
