North wall stability analysis of Vasilkovskoye open pit Kazakhstan

D. Dossymbek & A. Mortazavi

Nazarbayev University, Nur-Sultan, Kazakhstan

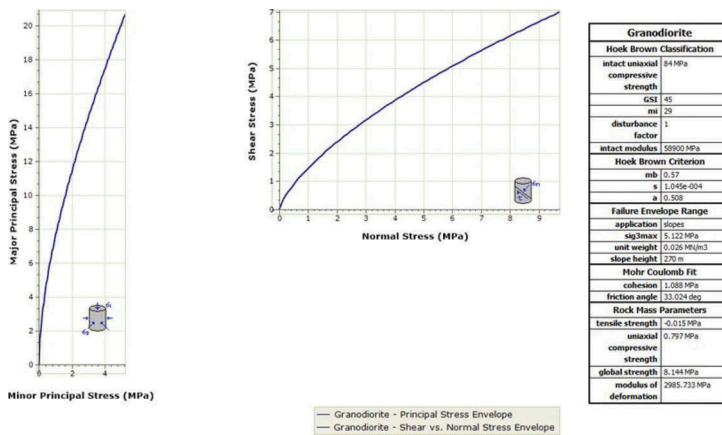
Figure 1. Rock mass designed data determined for Granodiorite geotechnical unit.

RocLab results for granodiorite, quartz diorite and gabbro-diorite are presented in Figure 1, 2 and 3.

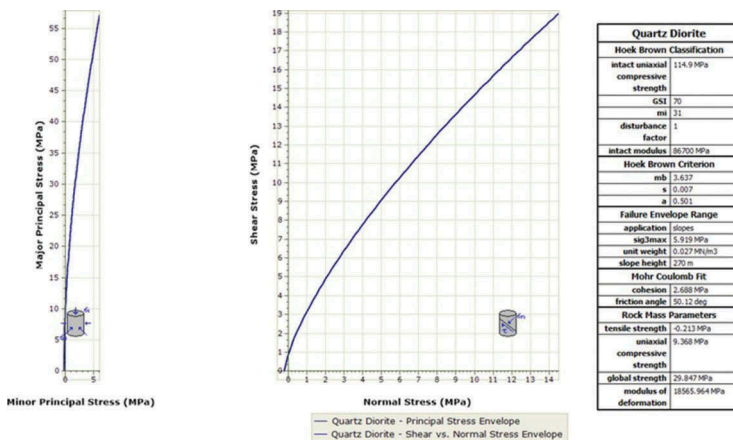
Figure 2. Rock mass designed data determined for Quartz Diorite geotechnical unit.

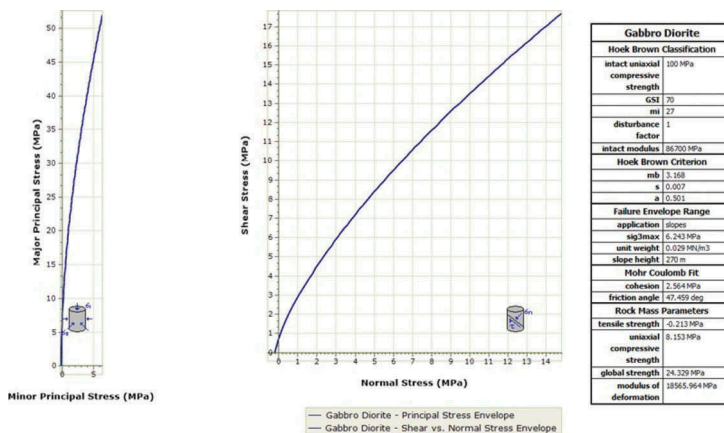
Figure 3. Rock mass designed data determined for Gabbro Diorite geotechnical unit.

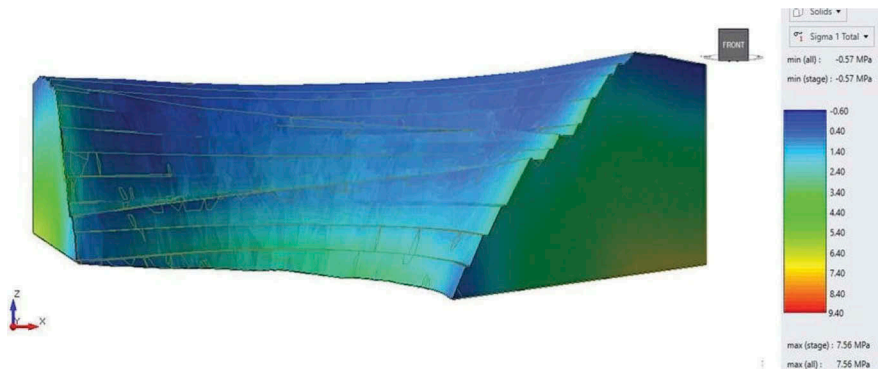
Thus, the maximum principal stress (σ_1) and the minimum principal stress (σ_3) were obtained from the simulation results using RS3. The calculated maximum principal stress was 7.56 MPa (Figure 4) and the minimum principal stress was found to be 7.14 MPa (Figure 5). Both stresses pose the greatest compressive stress on the basement of the north wall indicating lithostatic load, because of the mass of the overlying layers in rocks, and gravity that increases pressure on each layer of rock that increases with increasing depth.

Figure 4. The calculated maximum principle stress distribution within north wall (front view).

stated in the 3D numerical simulation of Vasilkovskoe north wall section both stresses pose the greatest strain on the basement of the north wall indicating the maximum principle stress as 7.56 MPa and the minimum principal stress as 7.14 MPa lithostatic load. Because of the mass of the overlying layers in rocks, and gravity, as being an increasing pressure on each layer of rock section, Figures 4 and 5 illustrate the base of the pit as the most stressed portion of the wall.

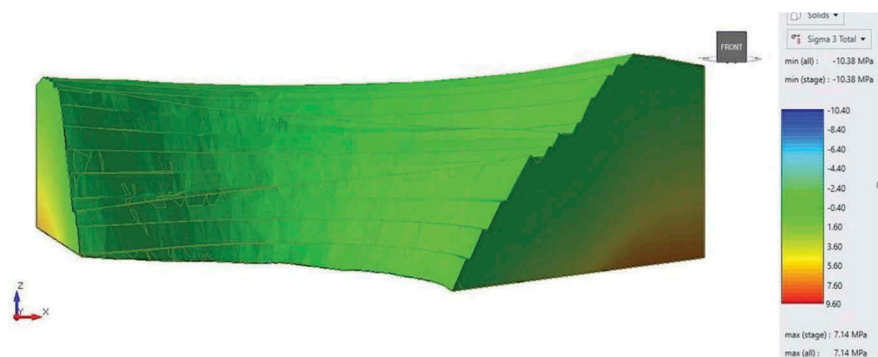
Figure 5. The calculated minimum principle stress distribution within north wall (front view).

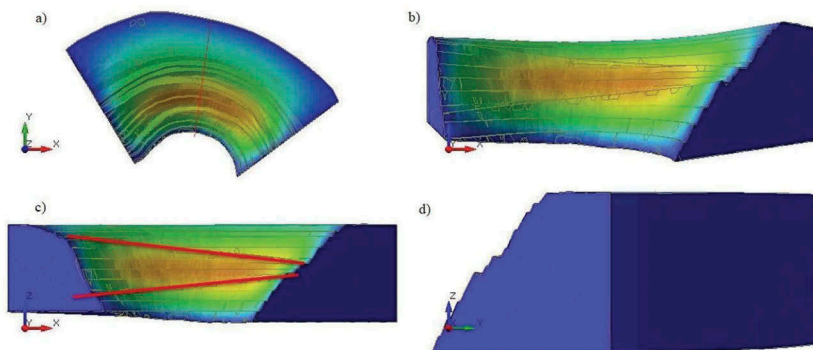
Distribution of total displacements within the North wall is shown in Figure 6. The contour of total displacement presented for a representative section of the wall in Figure 7. The results of the overall rock mass stability analyses indicated that the proposed design for pit walls are

As illustrated in Figure 6, the central section of the north wall possesses the highest instability potential within the whole structure. The overall size of the most unstable area corresponds to about 120 meters in length, 50 meters in height and 10 meters in depth and the probability of the maximum displacement is about 0.11 meters.

Figure 6. The calculated total displacement of the north wall (from four different perspectives: a) top view, b) isometric view, c) front view and d) side view).

With regard to limitations in computational capabilities, the model dimensions were selected as illustrated in Figure 6. Since this work in progress, for future publications, the model boundaries will be extended to minimize the probable errors associated with boundaries. Having prepared the data (Table 2) for the modelling, 3D model of the north wall of Vasilkovskoe open-pit was constructed within the RS3 environment. The north wall region was employing an average mesh size of 1m. Key geological materials were assigned as appropriate, RS3 software has a different approach for restraining the model. This model was restrained with auto surface restrain tool. Figure 4 and Figure 5 illustrates the determined maximum and minimum principal stress distribution within the simulated pit region.

As illustrated in Figure 6, the central section of the north wall possesses the highest instability among the whole structure. The main source of wall center instability is the distressing of wall and weak rock mass properties. The size of the predicted unstable area was found to be about 120 meters \times 50 meters \times 10 meters with an average displacement of 0.11 meters. Other simulation model predicts possible direction of the rock movement towards the center of the pit which poses a risk of several benches' failure. This indicates the risk for further operations on those benches. Bench, inter-ramp and overall slope geometries were studied by means of numerical simulation. It is suggested to follow the specific design criteria that will support the stability of the slope such as rock inter-ramp should comprise no more than about three benches and should have a vertical height of no more than 90 meters. These bench stacks should be separated by a 25-meter ramp or geotechnical berms.

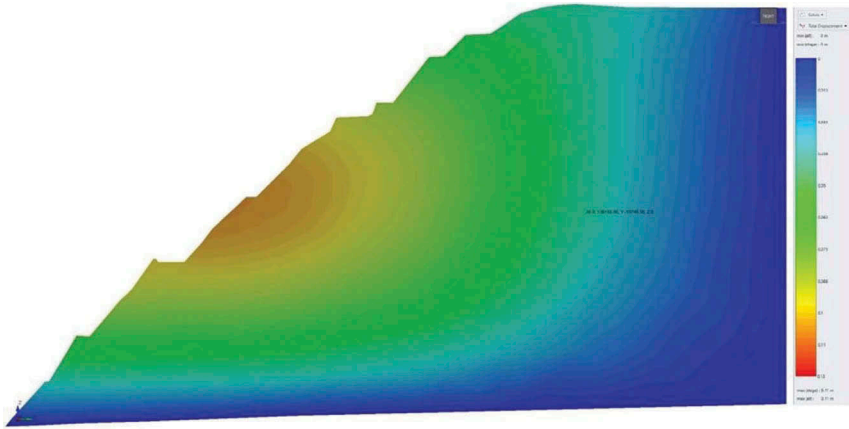
Figure 7. Total displacement contours on the north-south cross section.

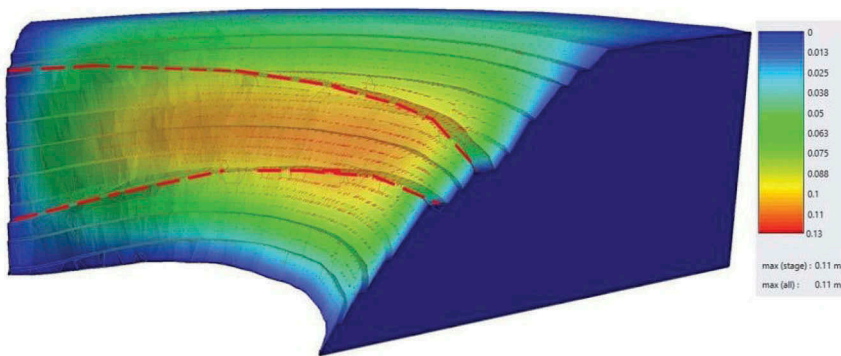
With the help of RS3 feature of displaying displacement vectors Figure 8 was obtained.

This model simulation allows us to predict possible direction of the rock movement. As vectors point to forward direction towards the center of the pit, it can be stated that there is a risk of several benches' failure. We have shown within 3D numerical modelling results that the north wall has the potential to fail, due to the wall is destressing potential at the middle

Figure 8. Displacement vectors direction.

portion. With regard to the jointed nature of the wall as the potential to fail at those areas, we recommend stabilization to the pit.
